Archaeology of Standing Buildings Survey
of the
Mission San Juan de Capistrano Chapel
Béxar County, Texas, USA

Kevin Coffee
University of Leicester
School of Archaeology & Ancient History
AR7524
23 September 2011

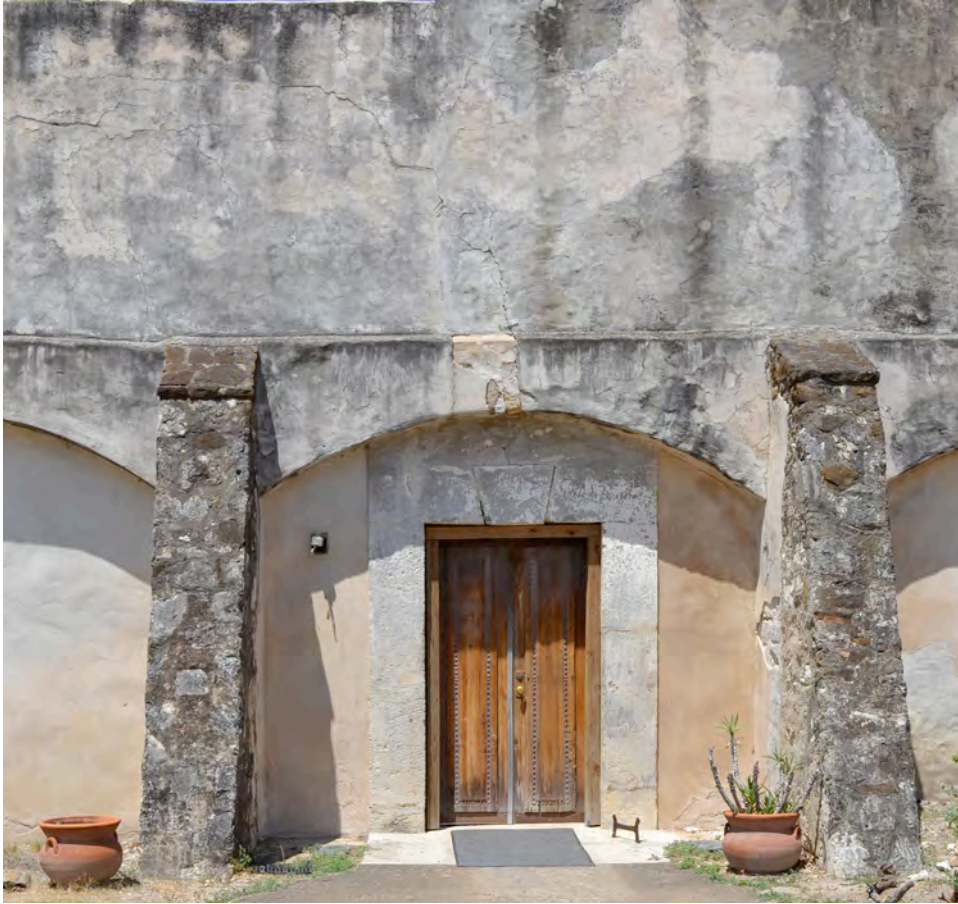
Plate 4. Main entry to the chapel. The C20 stucco cement was stained ca. 1963 and masonry buttresses were added ca. 1968 to several locations along the west and east elevations to provide 'historic' or 'antique' appearances. *Photograph by author.*

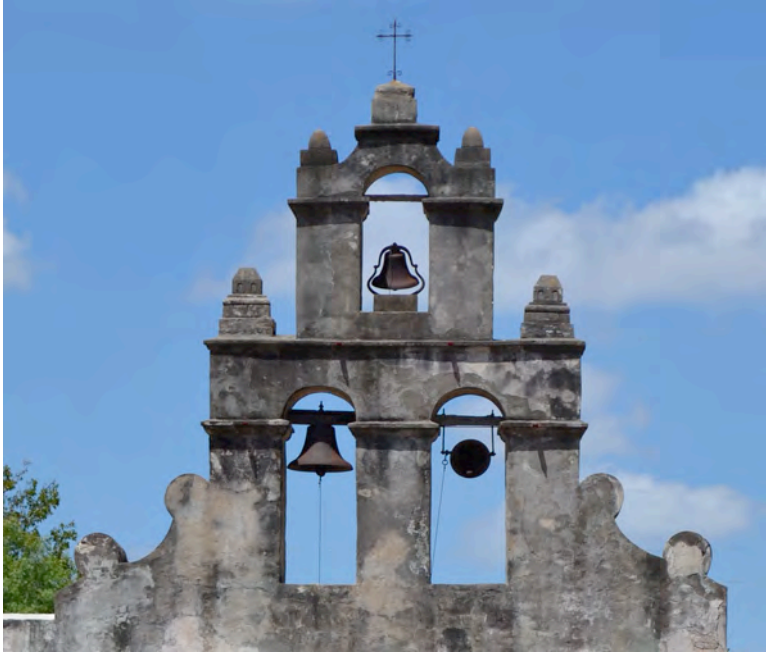
Plate 5. The bell tower is comprised of two tiers of masonry arches now covered with stucco. *Photograph by author.*

As noted, the bell tower rises above the northeast corner of the building. The bell arches have been completely covered in cement. The bell tower appears to lean to the east and is held in its present position by three iron rods that span the building to a location near the west parapet roofline (Plate 14).

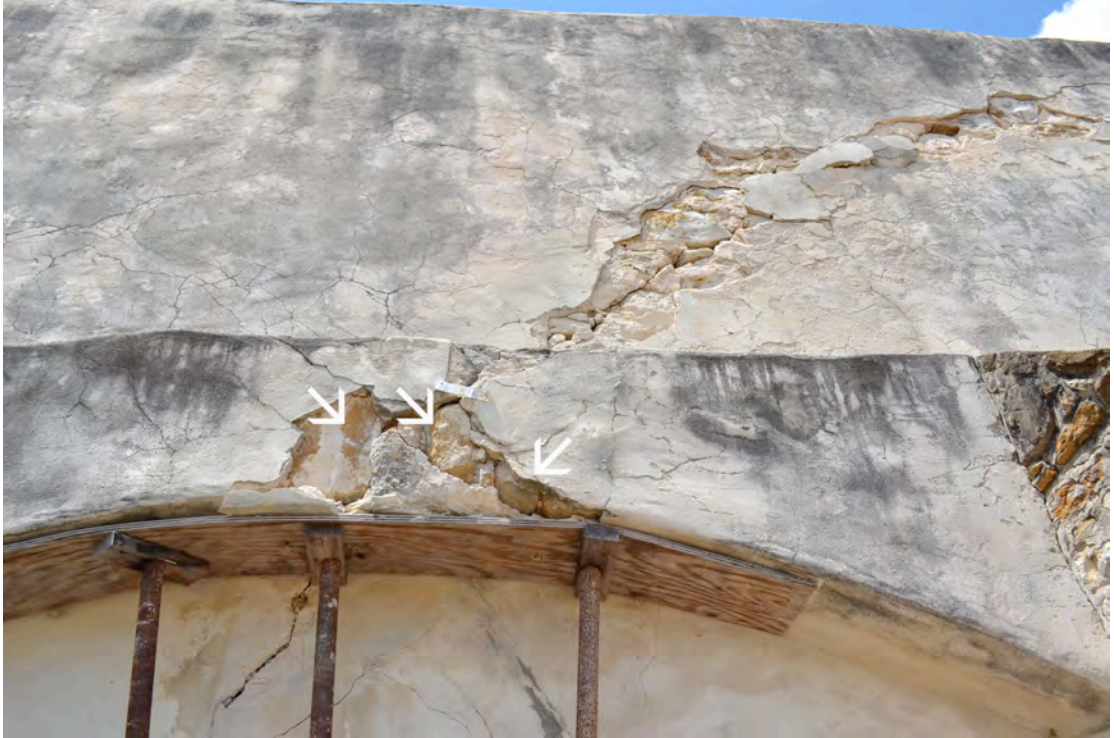
Of special note in the east elevation are the middle and south door apertures and ocular window aperture, each of which is supported by timber lintels or lintel assemblages rather than masonry arches, such as at the main entry and the ocular window in the west elevation. The use of ashlar at the main doorway is also unique.

Plate 13. Detail above middle door in east elevation revealing arch masonry. *Photograph by author.*

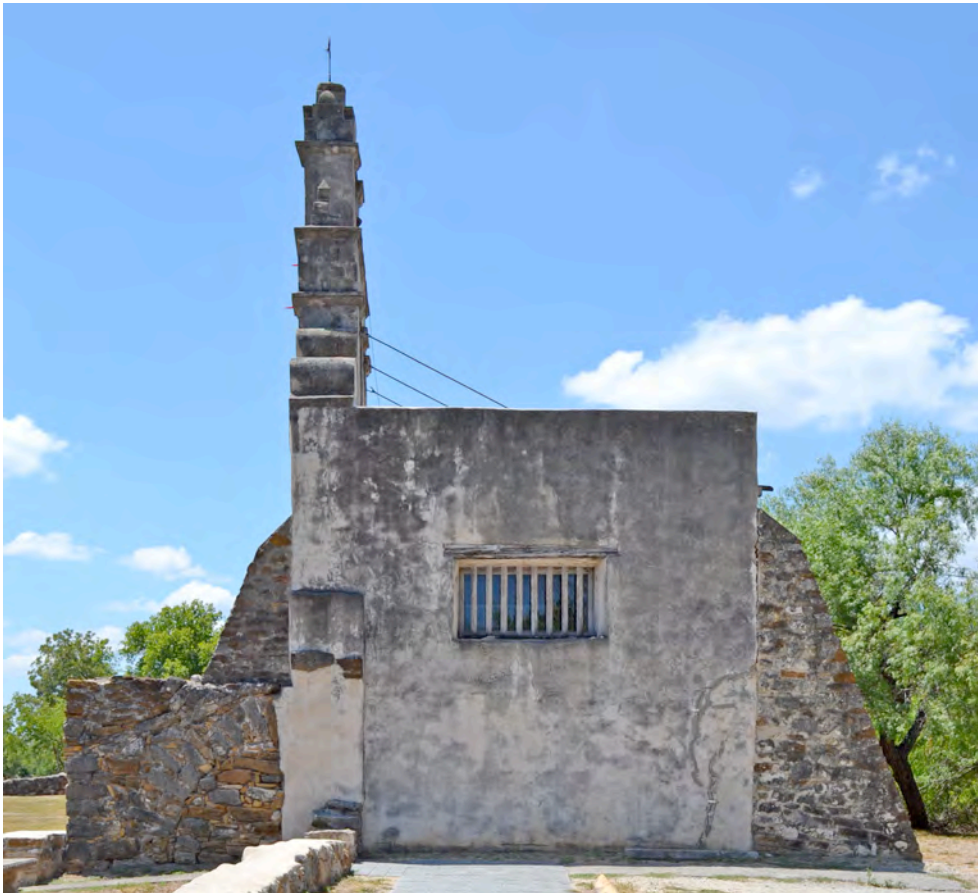
Plate 14. North elevation of chapel. *Photograph by author.*

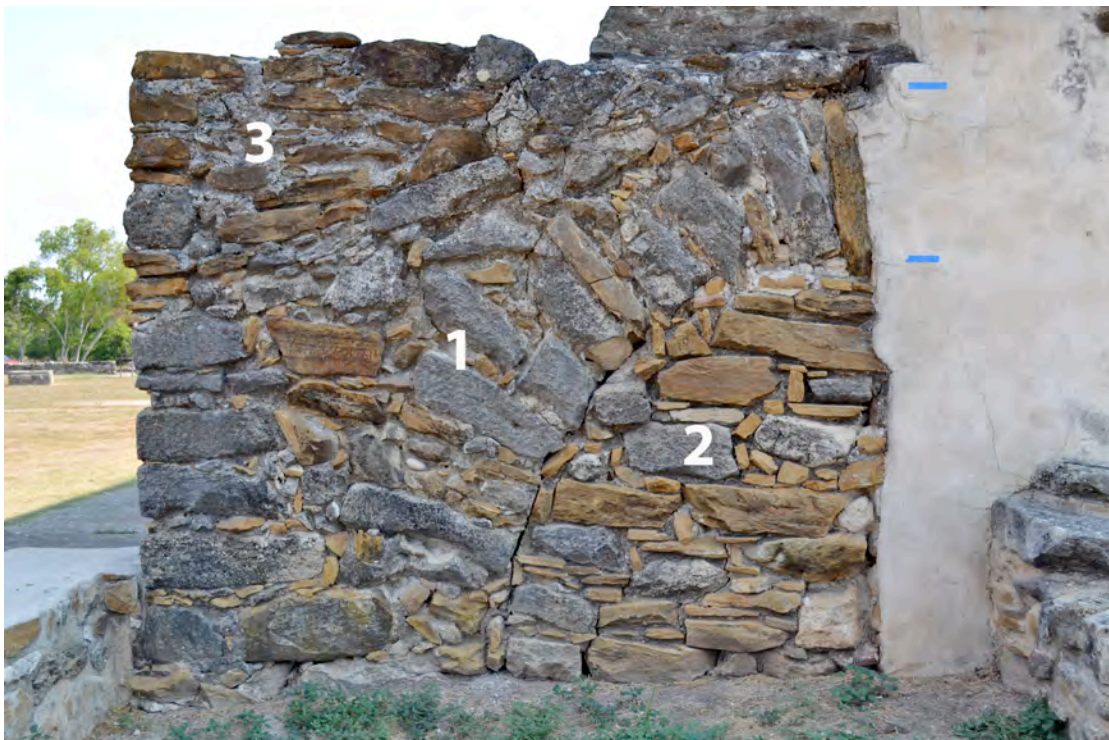
Attached to the north corner of the east elevation is a 2.6m high wall remnant that continues east approximately 2.9m from corner (B) of the building (Drawings 1, 6 & 7). This remnant includes a blocked-in arched buttress (Plate 15) that appears to have been built to support the east wall of the chapel building. The material of the buttress arch is consistent with masonry seen in the west elevation and the blocking material is visibly distinguishable below the arch. A later-period buttress has been built on top of this wall remnant.

Plate 15. Buttress (1) at northeast corner of chapel that was blocked (2) and squared off for use as a wall (3). *Photograph by author.*

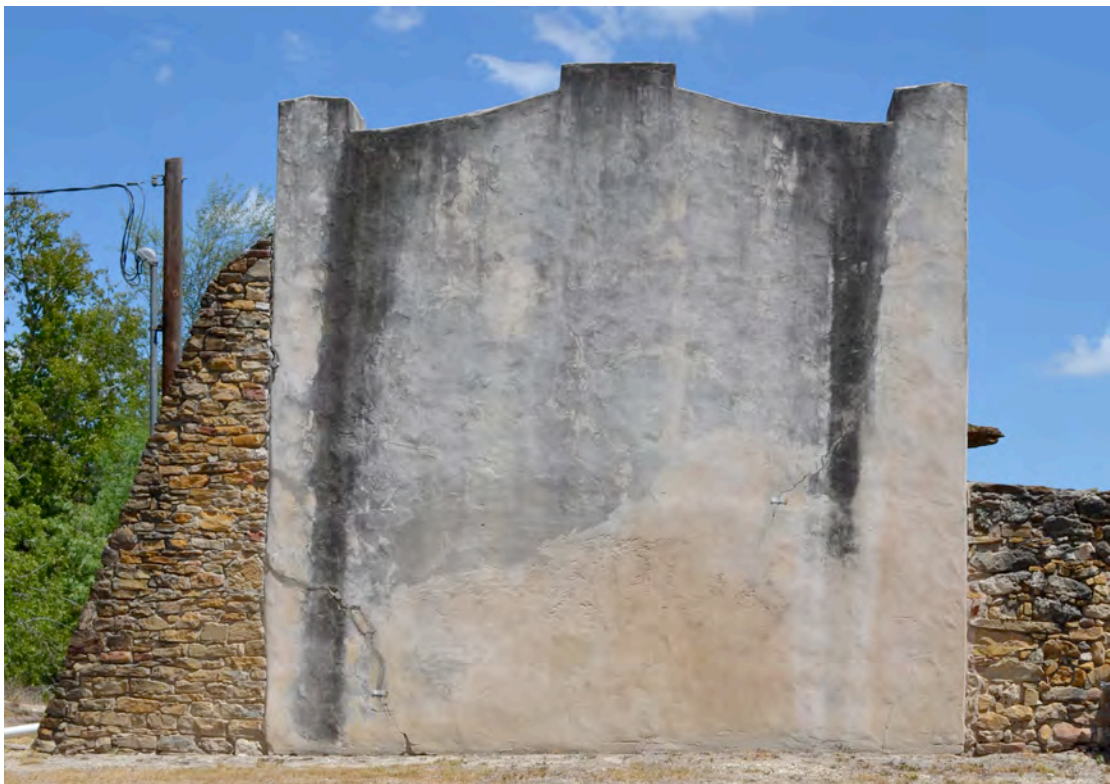
The south elevation is plain and completely faced with cement (Plate 16).

Plate 16. South elevation of chapel. *Photograph by author.*

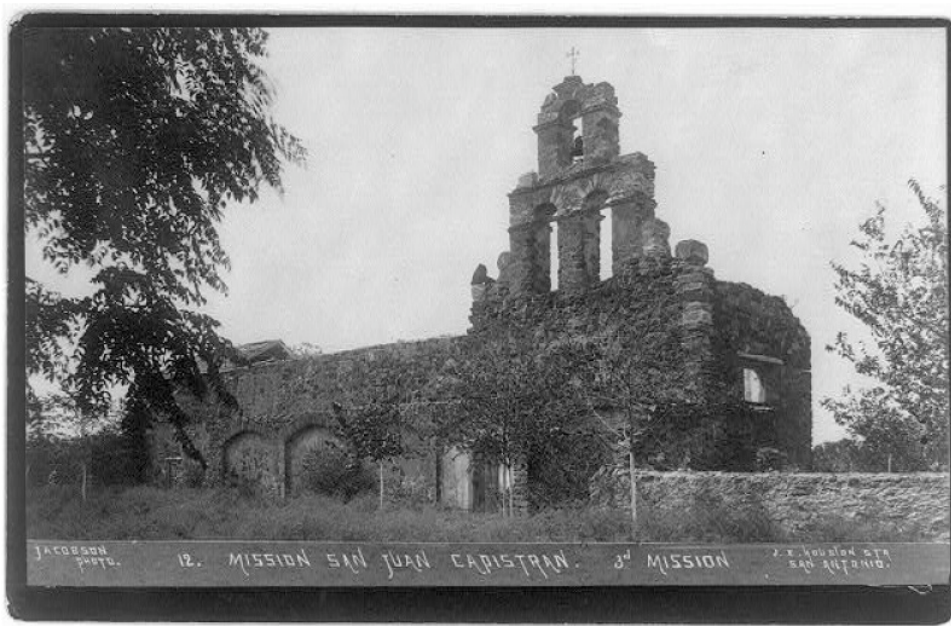
A photograph by M. E. Jacobson ca. 1890 provides an image of the chapel after the roof and, apparently, a section of the west elevation had been damaged by a severe storm (Plate 18). The masonry of the elevation and bell tower is clearly visible.

Plate 18. Photograph of chapel from northeast by M. Jacobson, ca. 1890. *Courtesy Library of Congress. Prints and Photographs Division. LC-USZ62-41542.*

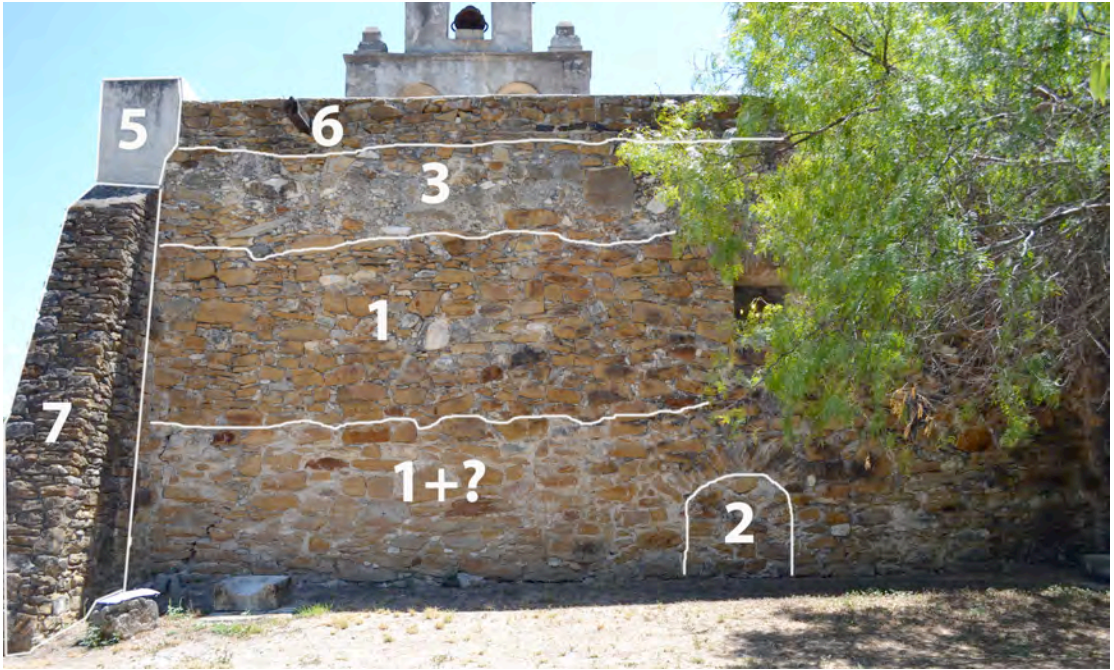
The west elevation, which is not covered by cement, presents exposed masonry construction that exhibits multiple phases of construction (Plate 23, 24 & 25). The first phase is seen in the predominantly sandstone construction that initially extended from grade to above the ocular window opening. This section of the wall appears as a systematically assembled unit rising past the straight arch of the window. The blocked-in archway below the window, the block sizes, assembly and mortar joints are consistent with the early- to mid-C18 construction technique used elsewhere at this site (Plate 27, 15).

Plate 23. Phasing diagram of north bay of west elevation. *Photograph by author.*

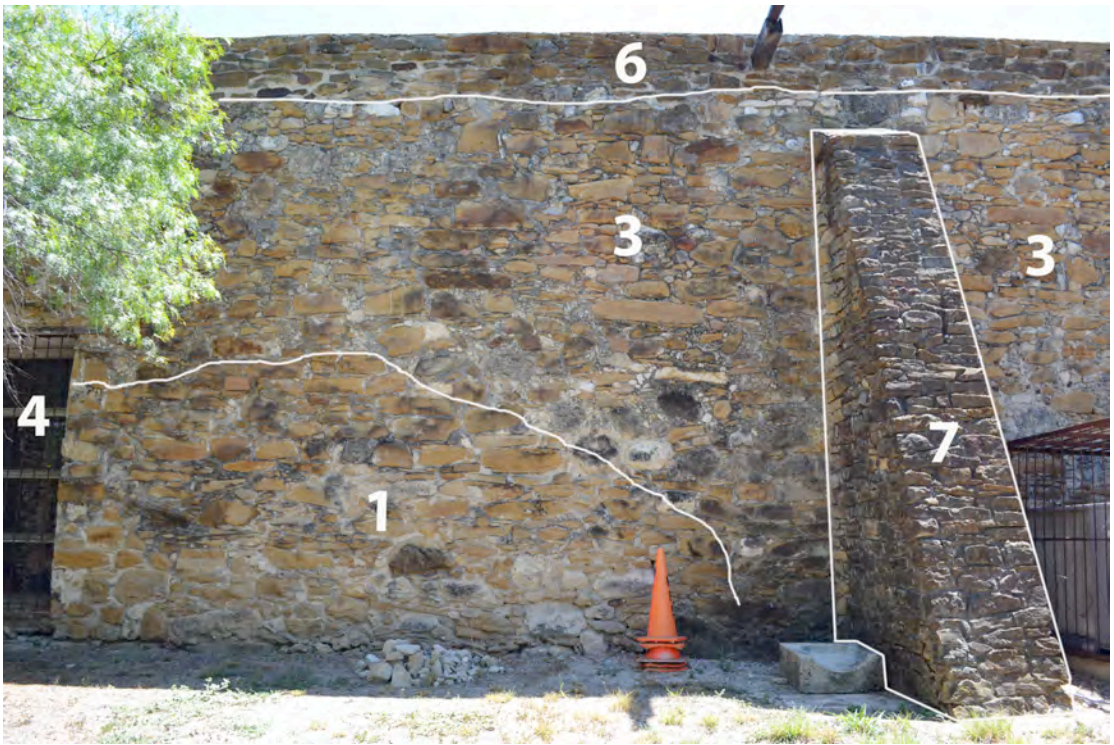
Plate 24. Phasing diagram of middle bay of west elevation. *Photograph by author.*

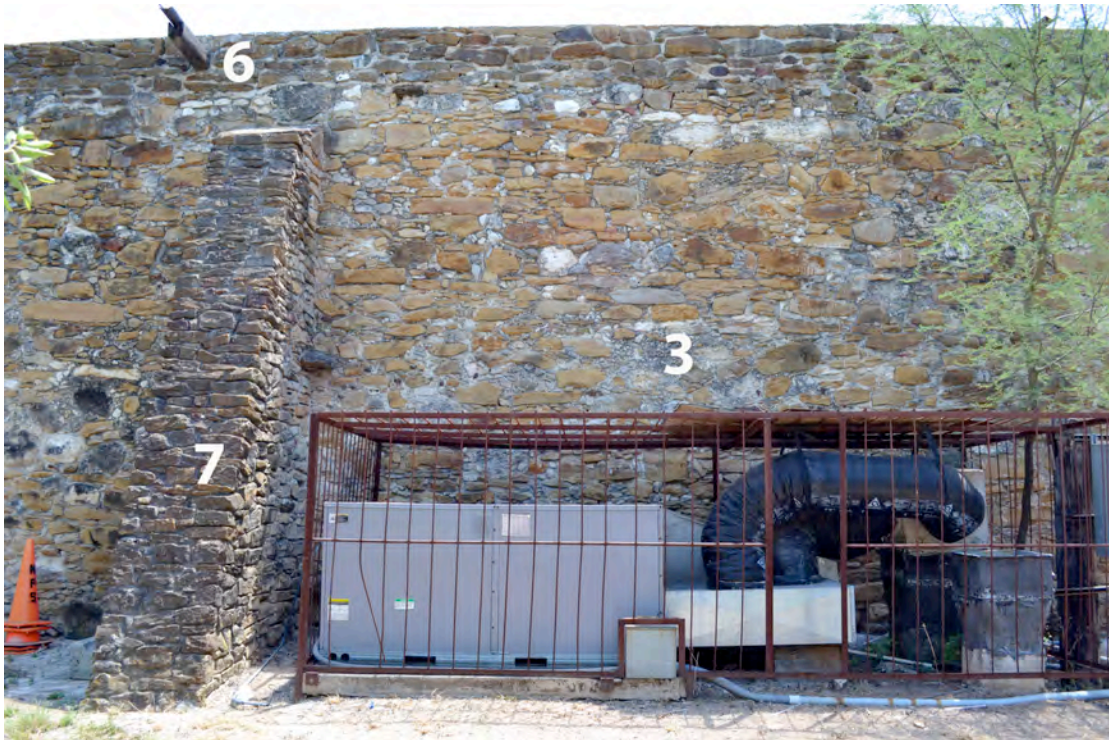
Plate 25. Phasing diagram of south bay of west elevation. *Photograph by author.*

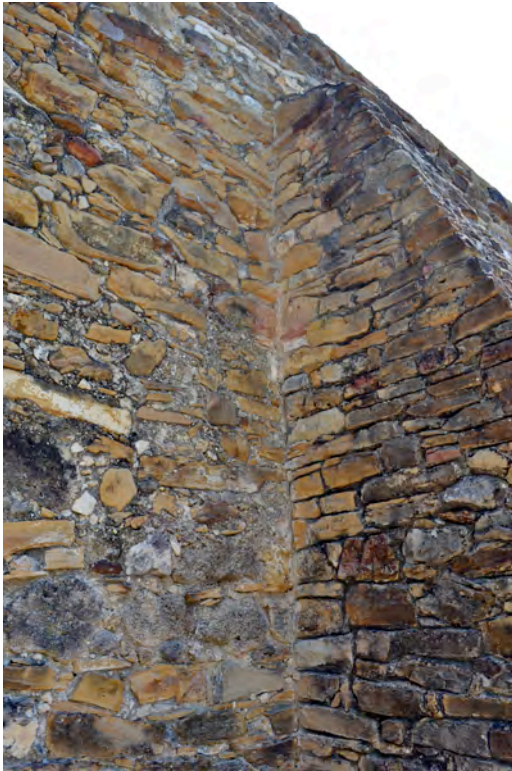
Plate 26. Highly variegated stone [left] mixed with gravelly cement in west elevation. *Photograph by author.*

The third phase of construction is evident in the area higher up in the first buttress bay, approximately 4m above grade, appearing as an aggregate of highly variegated stones mixed with gravel and cement (Plate 26). This section appears as a significant repair to the wall and was perhaps an effort to restore it to a previous height, as it meets what appears to be a pre-existing sandstone section immediately south of it along the west elevation. This type of construction continues south along the west elevation into the middle bay, sloping downward toward grade through to the south bay.

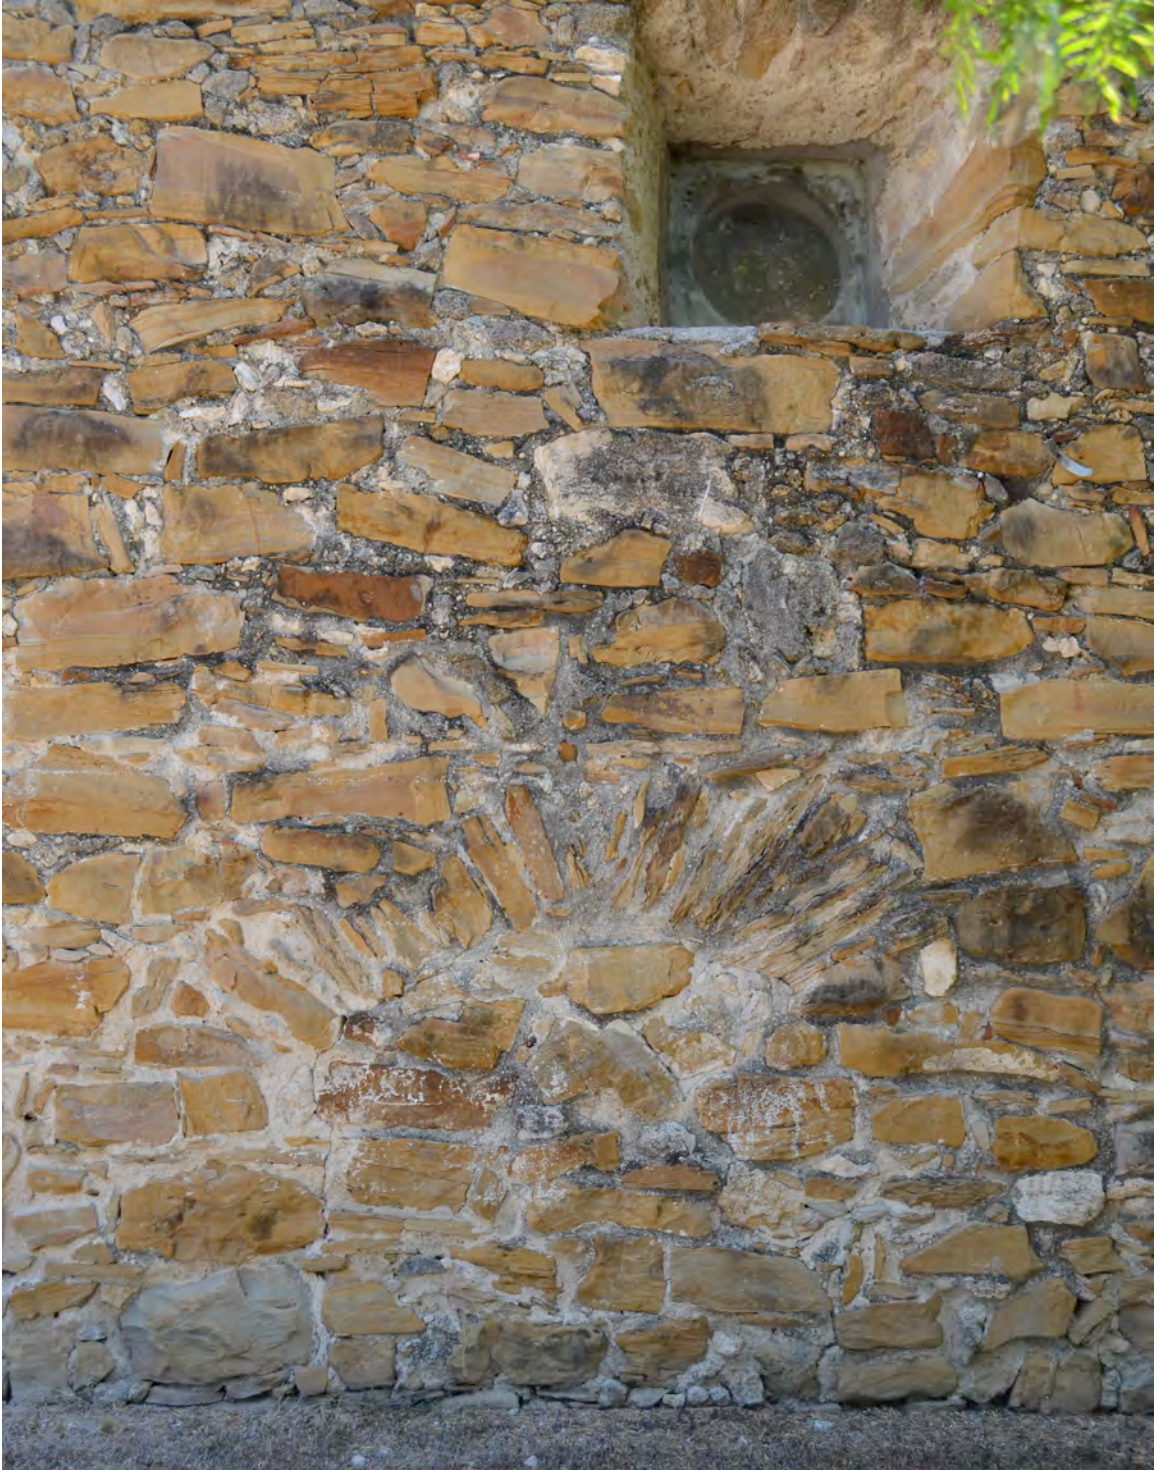
A lower part of the phase one sandstone wall [indicated by '1+?'] immediately north of the blocked archway displays an intermittent and partial application of mortar over the faces of some blocks. This appears to be an incomplete repair effort that was possibly intended to retain loose mortar between the sandstone blocks.

Plate A. West Elevation detail of blocked arch. *Photograph by author.*

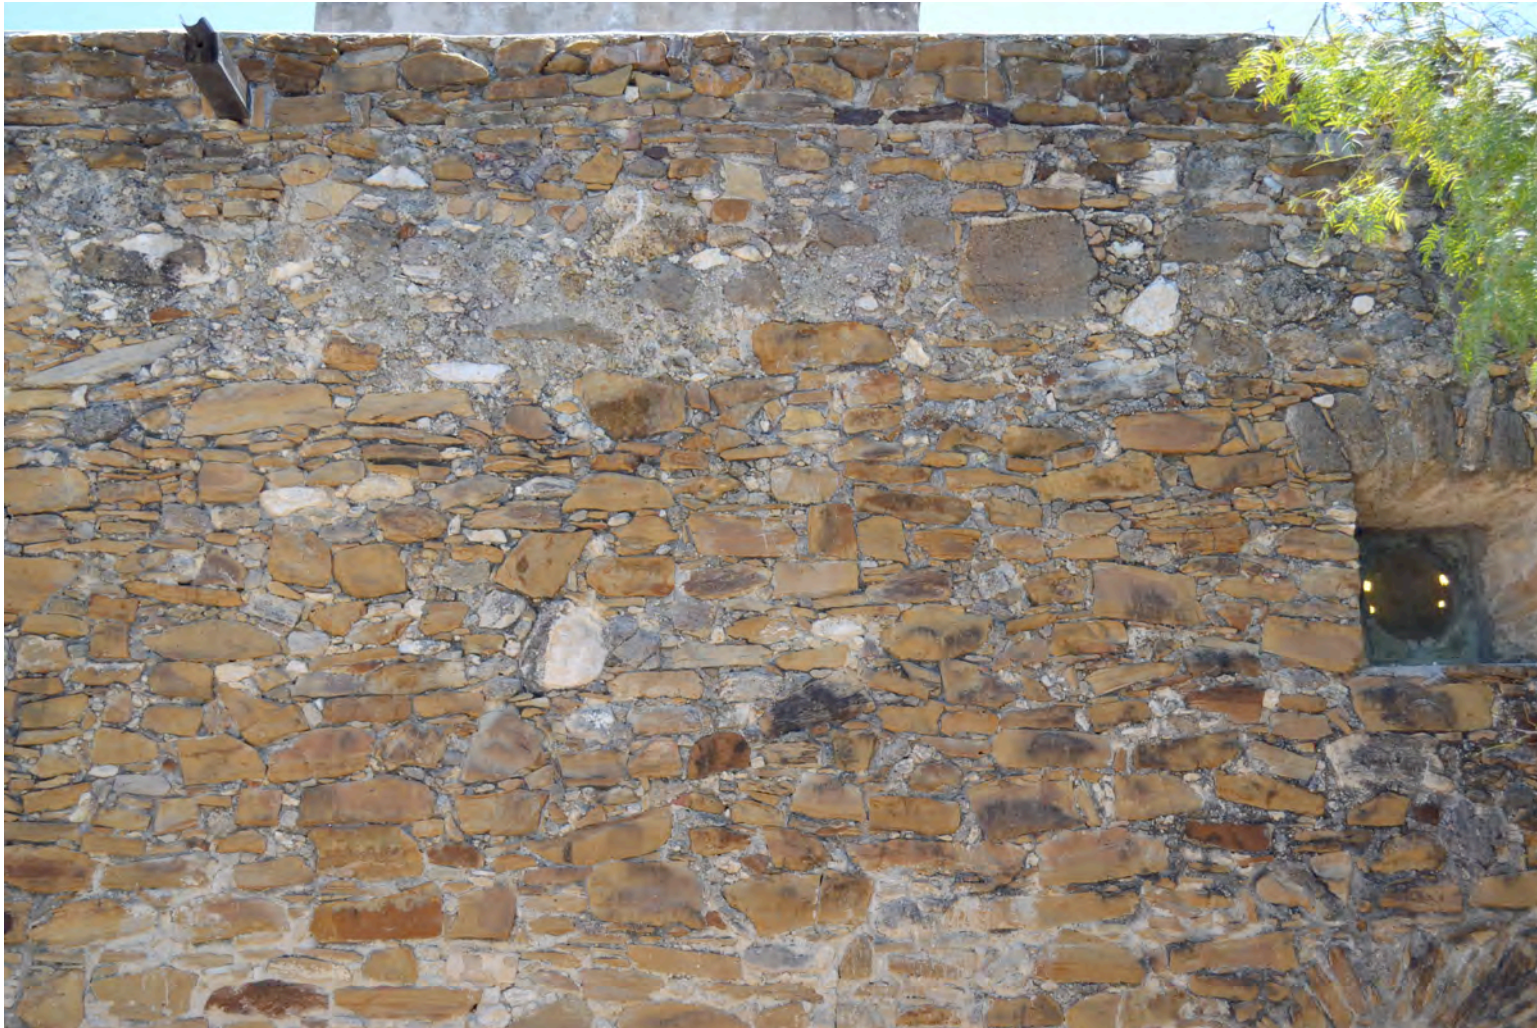
Plate B. North bay of west elevation showing top of wall with random stone repairs above ocular window. *Photo by author.*
