Archaeology of Standing Buildings Survey
of the
Mission San Juan de Capistrano Chapel
Béxar County, Texas, USA

Kevin Coffee
University of Leicester
School of Archaeology & Ancient History
AR7524
23 September 2011

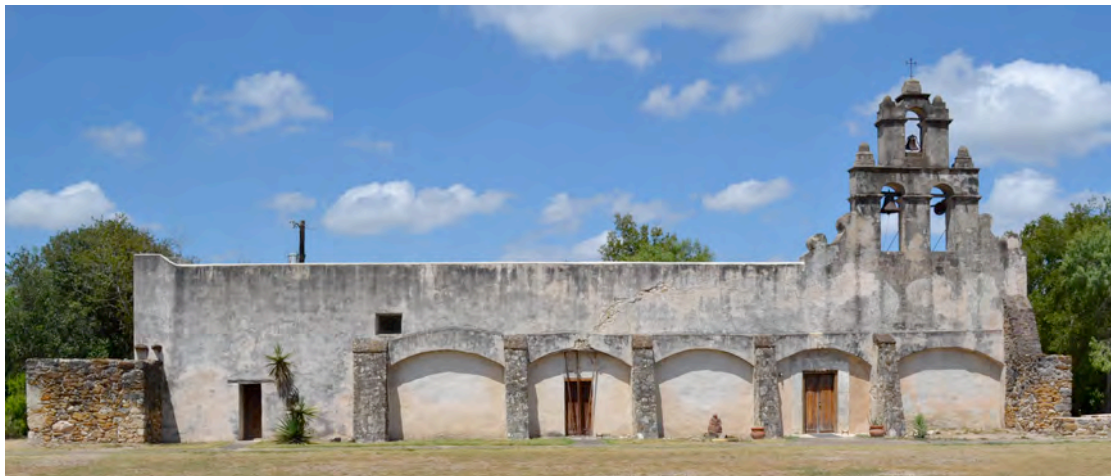
Plate 2. The east elevation of the chapel with adjacent boundary wall remnants to north and south, as viewed from the center of the Mission plaza. *Photograph by author.*

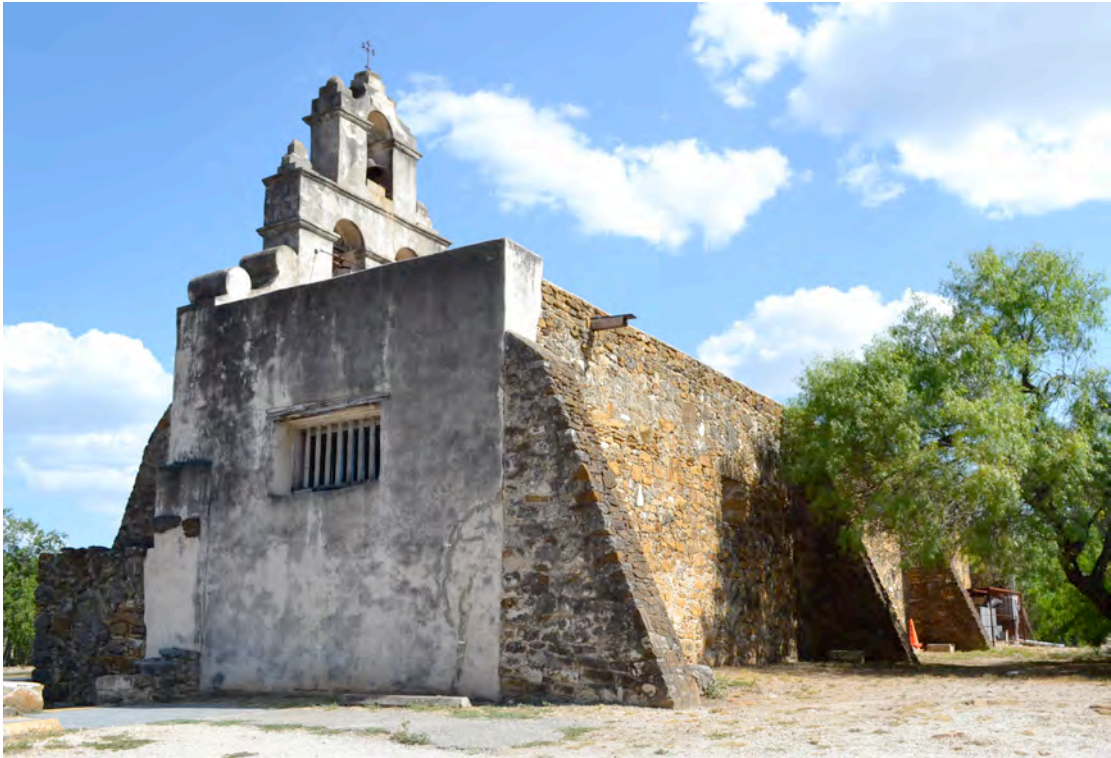
Plate 3. The north and west elevations of the chapel, looking southeast. *Photograph by author.*

The west elevation (Plate 3, Drawing 5), which is not covered with cement, presents exposed masonry construction that exhibits multiple phases of construction and use. These are discussed at greater length in the analysis below. The elevation is

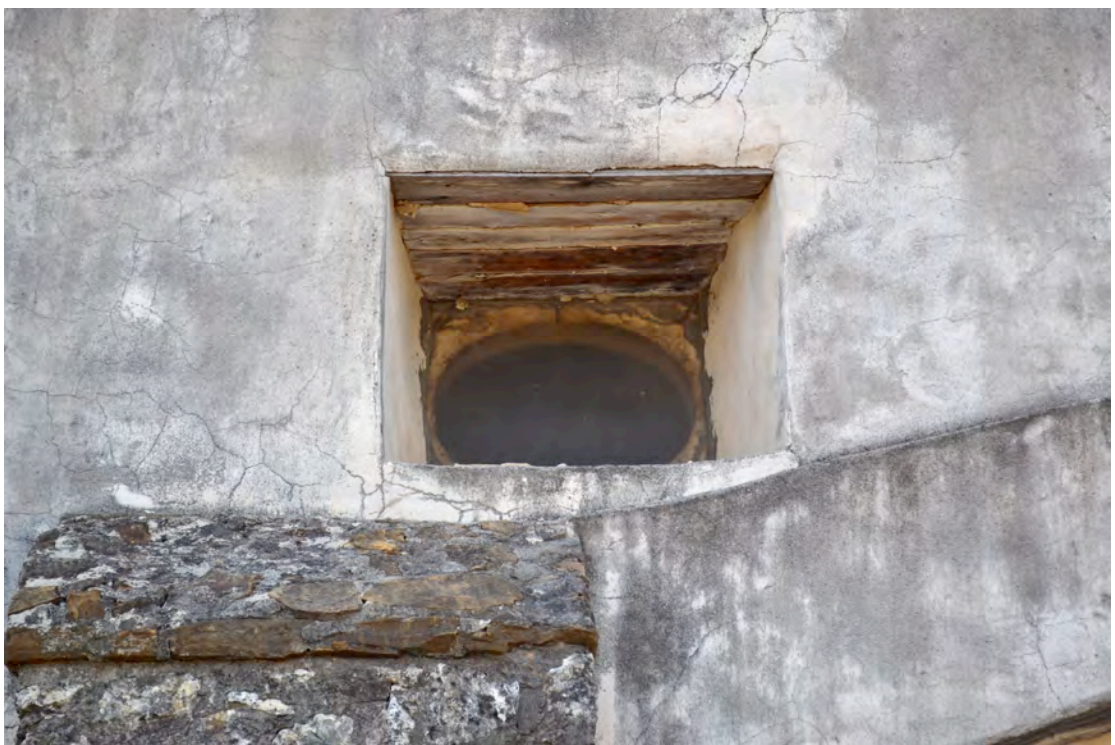
Plate 8. Ocular window at southeast corner of nave. *Photograph by author.*

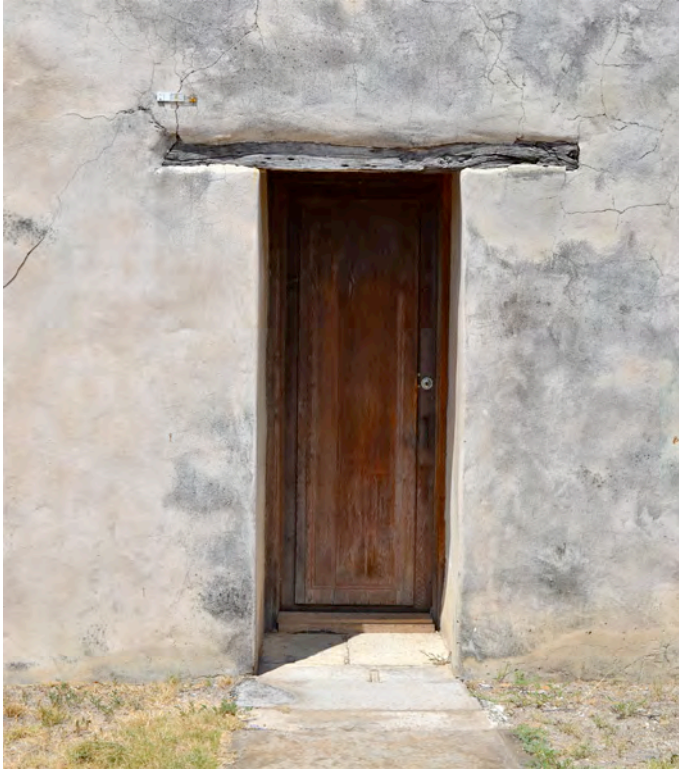
Plate 11. Sacristy door with timber lintel. *Photograph by author.*

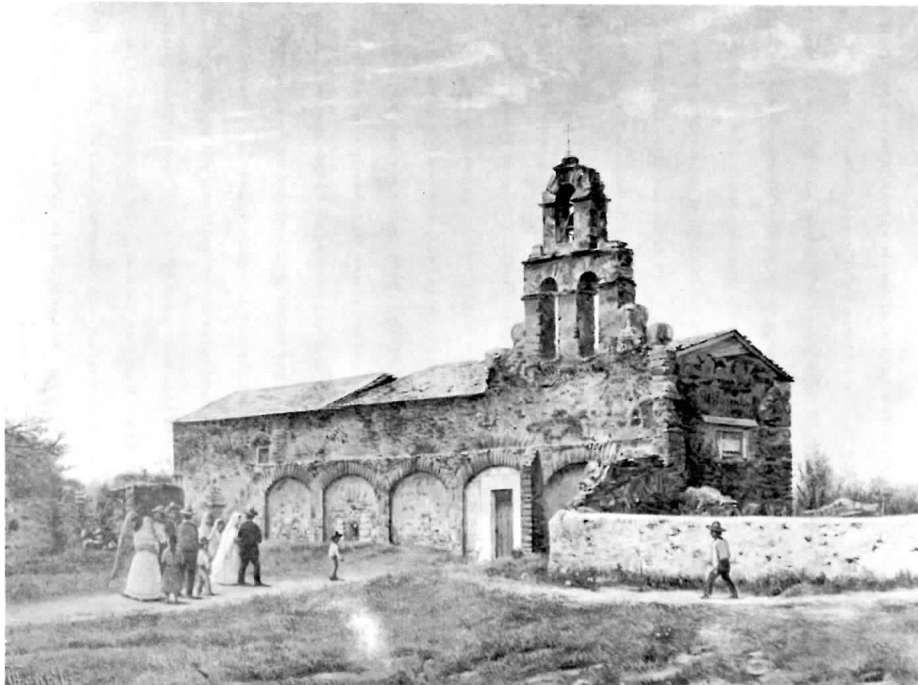
Photographs, drawings and paintings of the chapel building also provide comparative information regarding its structural history over the past 150 years. An early image of the chapel comes from a ca. 1870 painting by Théodore Gentilz, which depicts the east and north elevations and a hipped roof (Plate 17).

Plate 17. Painting of chapel from northeast by Théodore Gentilz, ca. 1870. *Yanaguana Society*, #924.

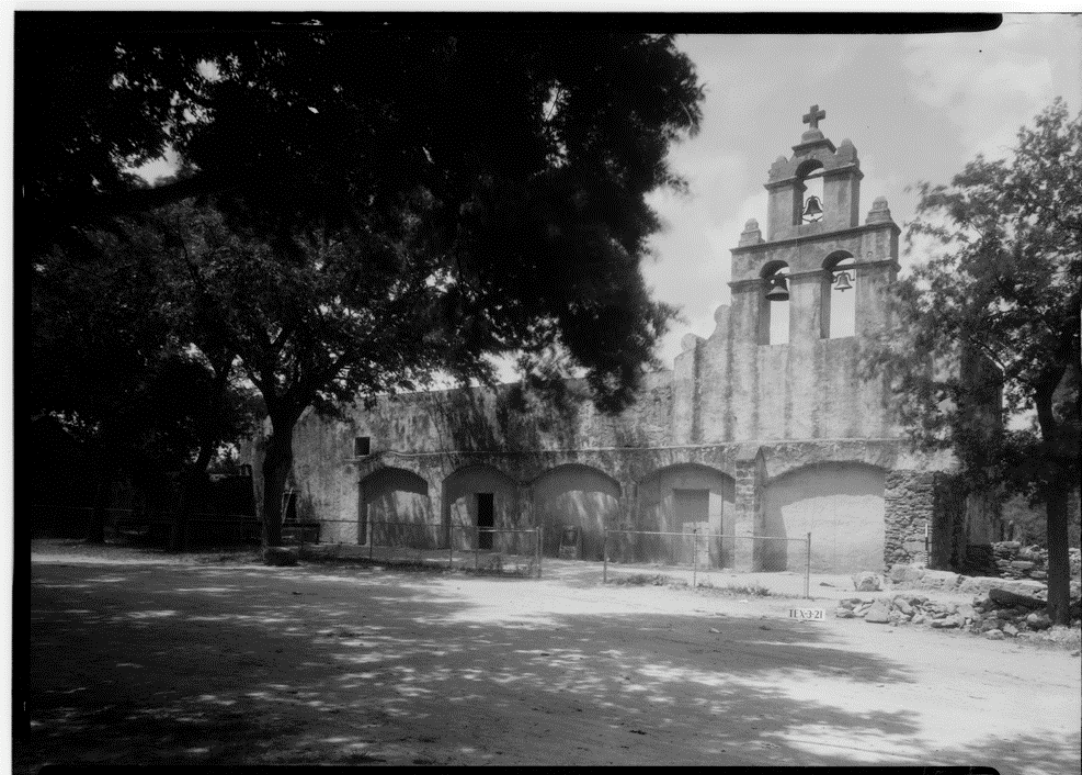
A 1936 HABS photograph shows the exterior of the chapel 28 years after renovations by the Diocese, such as masonry cement (Plate 19).

Plate 19. San Juan de Capistrano Chapel in 1936. *Photograph by Arthur W. Stewart. Courtesy Library of Congress. Prints and Photographs Division. HABS TEX.15-SANT.V3-2.*

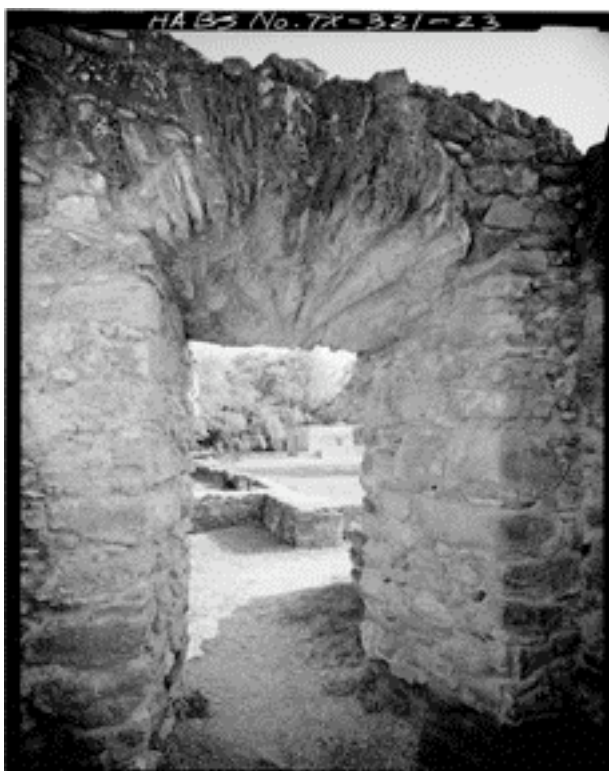
Those parts of the chapel that feature complex masonry such as the west ocular window, the northeast buttress, the archways along the east elevation and the blocked-in arch on west elevation demonstrate a distinct architectural and engineering concept (Plate 27). The simpler wooden framed windows demonstrate a different construction technique very likely responding to economic pressures and constrained resources, as

Plate 27. Arched doorway of 'half-finished church' bapistry looking southwest, 1983. *Photograph by Jet Lowe. Courtesy Library of Congress. Prints and Photographs Division. HABS TEX.15-SANT.V.3.23.*

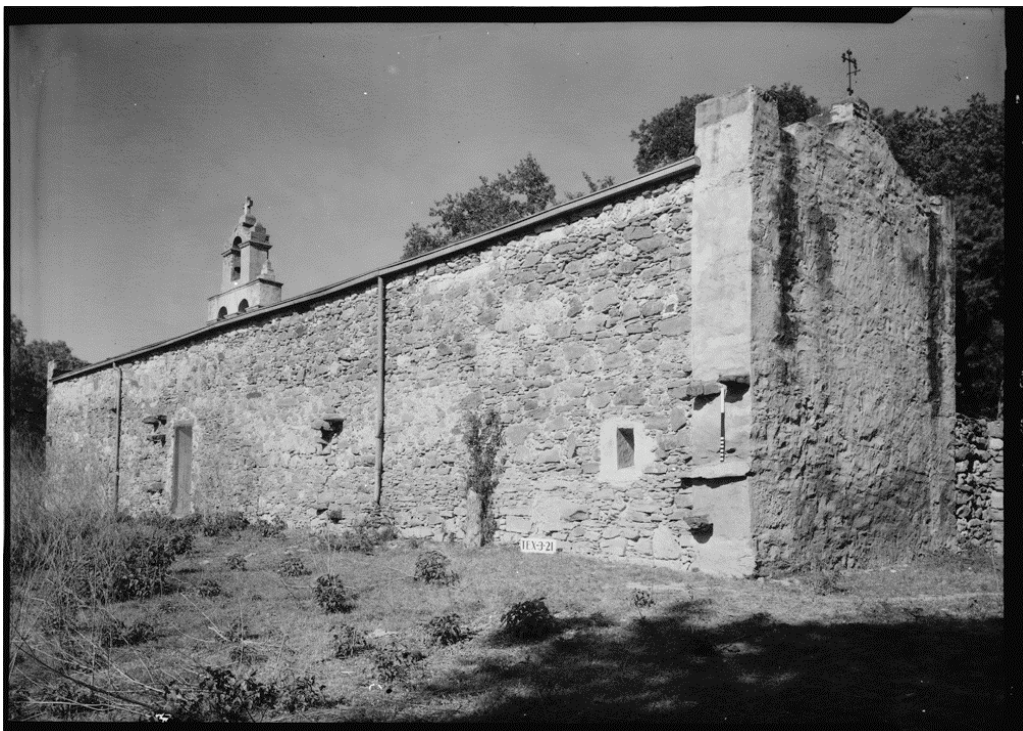
Plate 27. 1936 southwest elevation of chapel. *Photograph by Arthur W. Stewart. Courtesy Library of Congress. Prints and Photographs Division. HABS TEX.15-SANT.V.3-4.*
